## **FAILURE REPORT**

### **CALGARY GGS-STATION 3**

**01-23-45-6W1 License #XYZ123**

### **Gas Line**

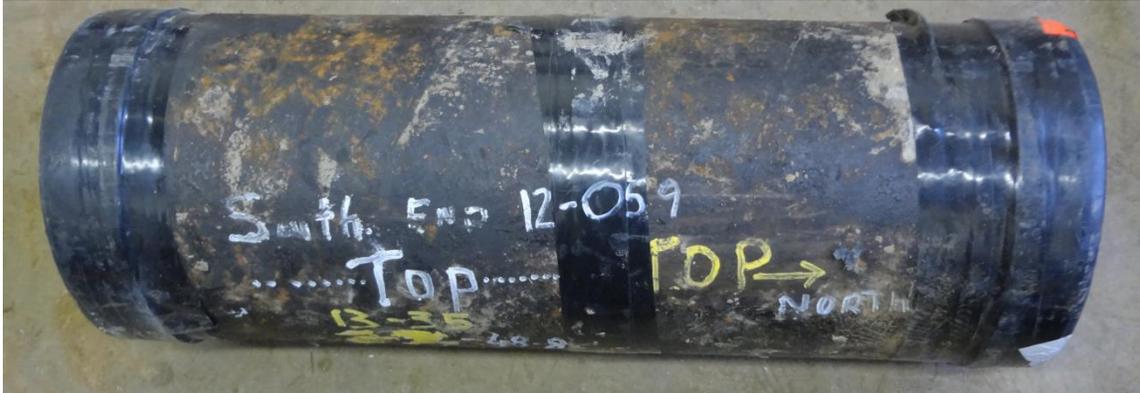
**Figure 1: Sample as Received**

'SOUTH' and 'NORTH' (see figures 1-2). Flow being expected from the south to the north end.

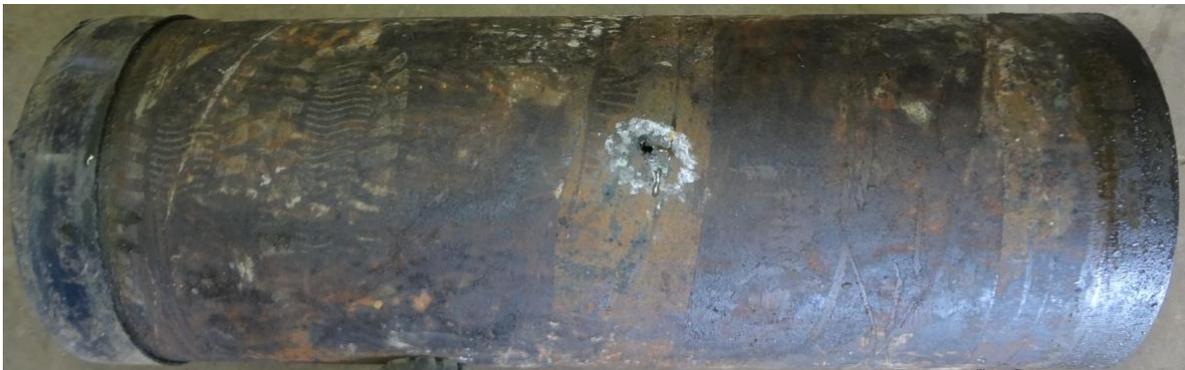
**Figure 2: The failure after the black tape was removed**

Based on the indicated orientation the failure had occurred at the 6 o'clock position 41.5cm from inlet. The failure was encompassed with black electrical tape.

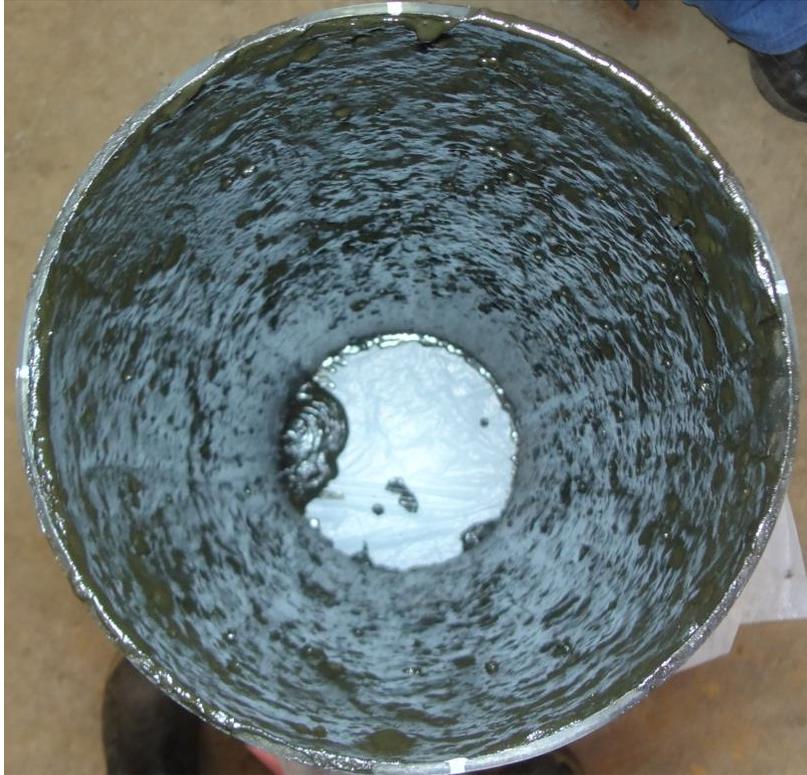
**Figure 3: Heavy Deposition of Solids**

The internal surfaces were laden with a thick, dark grey slimy sludge. The substance was wet, had a foul odour and was somewhat runny. Due to the odour and abundance of deposition, a Hydrogenase test was conducted to assess if bacteriological matter was present. The test proved negative for active bacteria.

- 9.1 *Consider a line clean out to remove loosely adherent deposits or installation of pigging facilities to accomplish the same goal.***

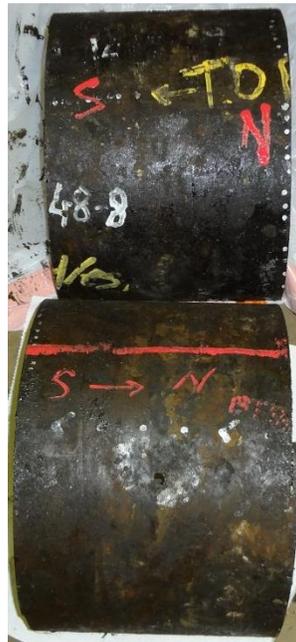
**Figure 4: External walls after splitting**

Pictures were taken of the sample as received and after a 20 cm segment had been removed for analysis at the failure location. The sample was split at 3 and 9 o'clock to perform a detailed assessment of the internal defects.

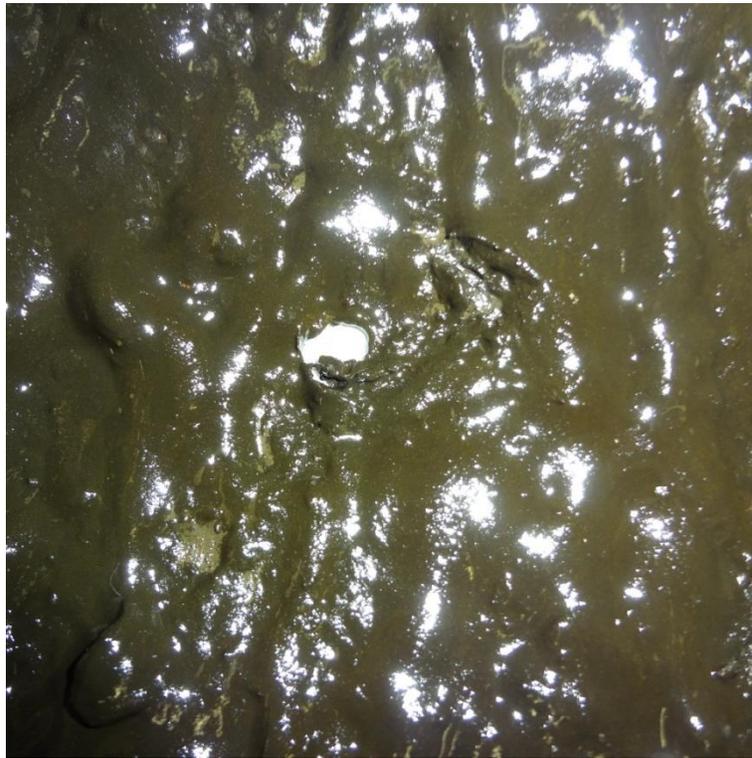
**Figure 6: Internal failure prior to cleaning with heavy deposition**

A deposit sample was collected from the pit for X-Ray Diffraction analysis. A sulphide spot test was performed prior to cleaning and indicated a positive result.

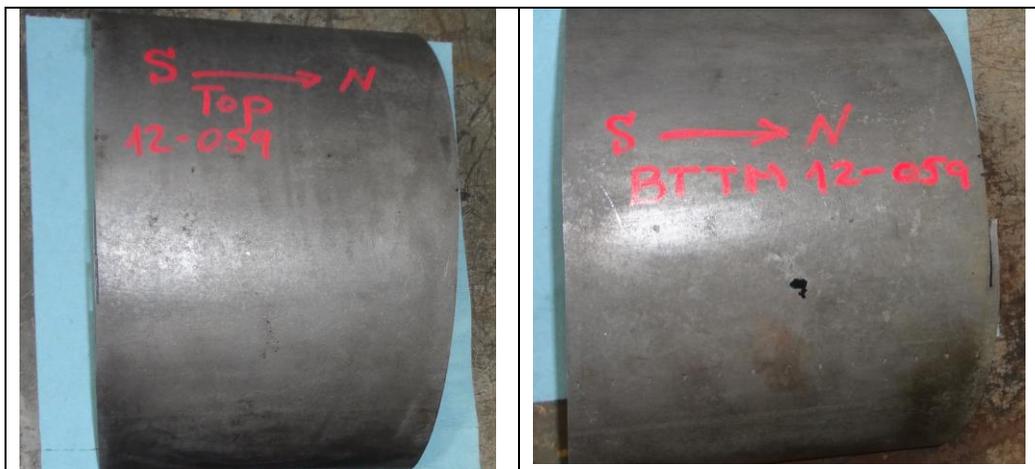
Figure 8: External walls after acid cleaning

The following series of photographs illustrate the defect morphology with the most severe corrosion being in 6:00 o'clock location.

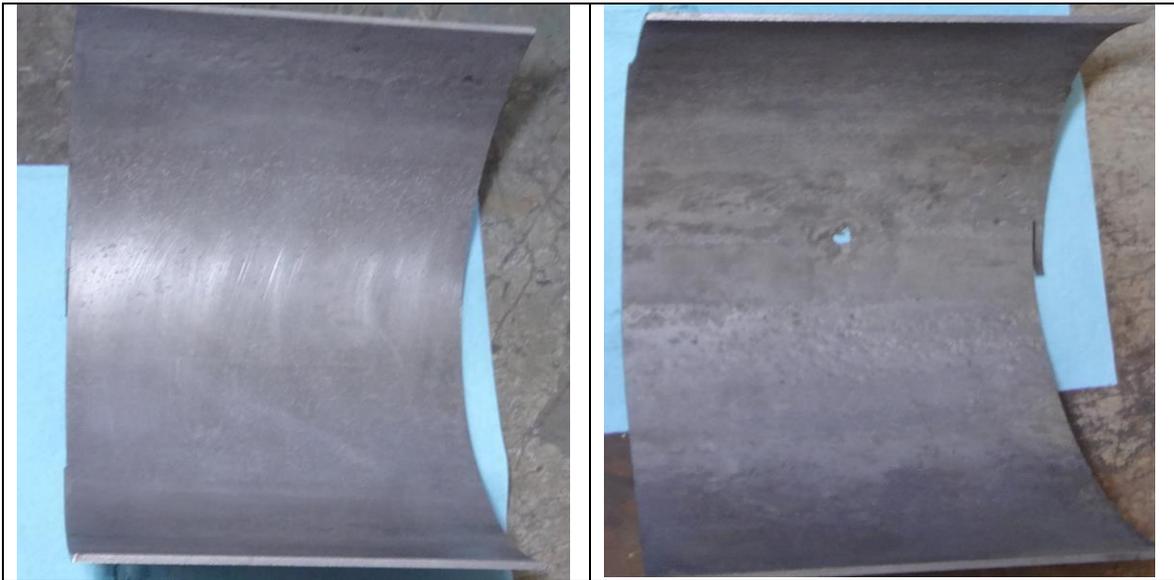
**Figure 10: Internal walls after acid cleaning**

Corrosion activity was most severe to the bottom of the line. The top quadrant had frequent isolated etching attack with corrosion becoming more pronounced at the 2 and 10 o'clock positions. From 5 to 7 o'clock there was a continuous area of general corrosion including the through wall pitting attack in the 6 o'clock position.

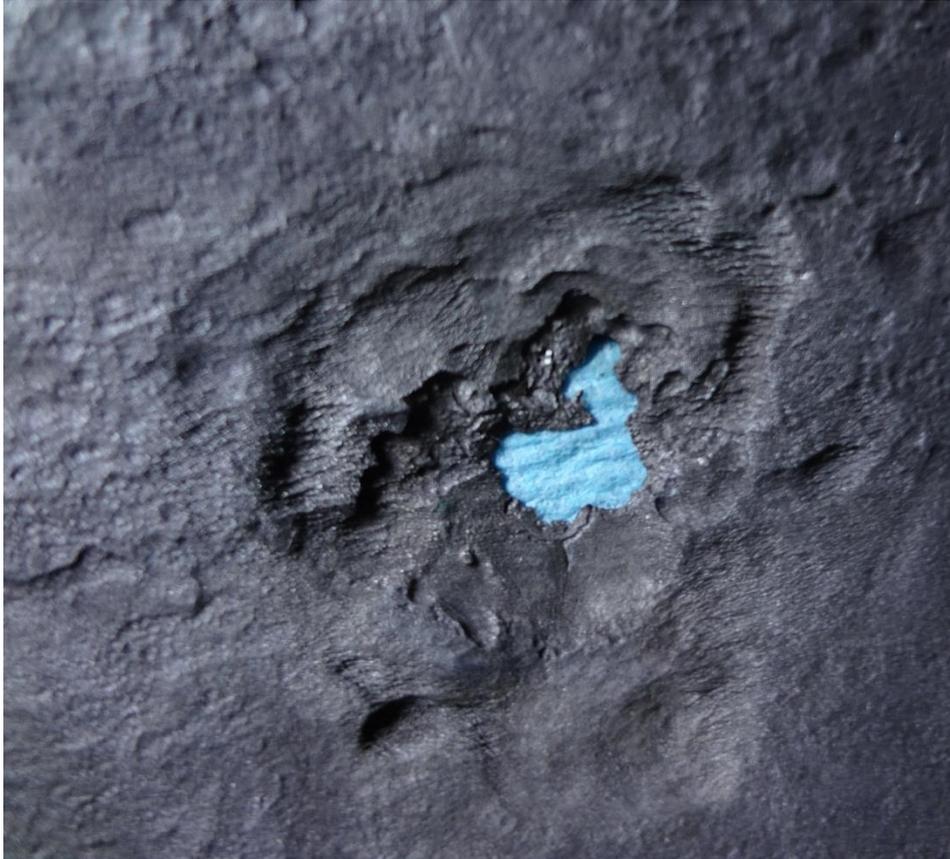
**Figure 11: Internal failure close-up after acid cleaning**

ERW was at the 9:30 o'clock position. The failure pit measured 34mm in length, 41mm in width and was through wall.

The primary corrosion mechanism was an under deposit type of attack, CO<sub>2</sub> was the driving mechanism for corrosion. The majority of the corrosion by-product was siderite from CO<sub>2</sub> corrosion. The produced brine is high in bicarbonate which may reduce the rate of corrosion. Goethite in the corrosion product is most likely oxidized iron sulphides. Spot tests on the wall of the sample indicated a positive for sulphide deposits and this was confirmed in the XRD analysis.
